CIVIL AERONAUTICS BOARD

AIRCRAFT ACCIDENT REPORT

UNITED AIR LINES, INC.
BOEING 727, N7030U
SALT LAKE CITY, UTAH
NOVEMBER 11, 1965

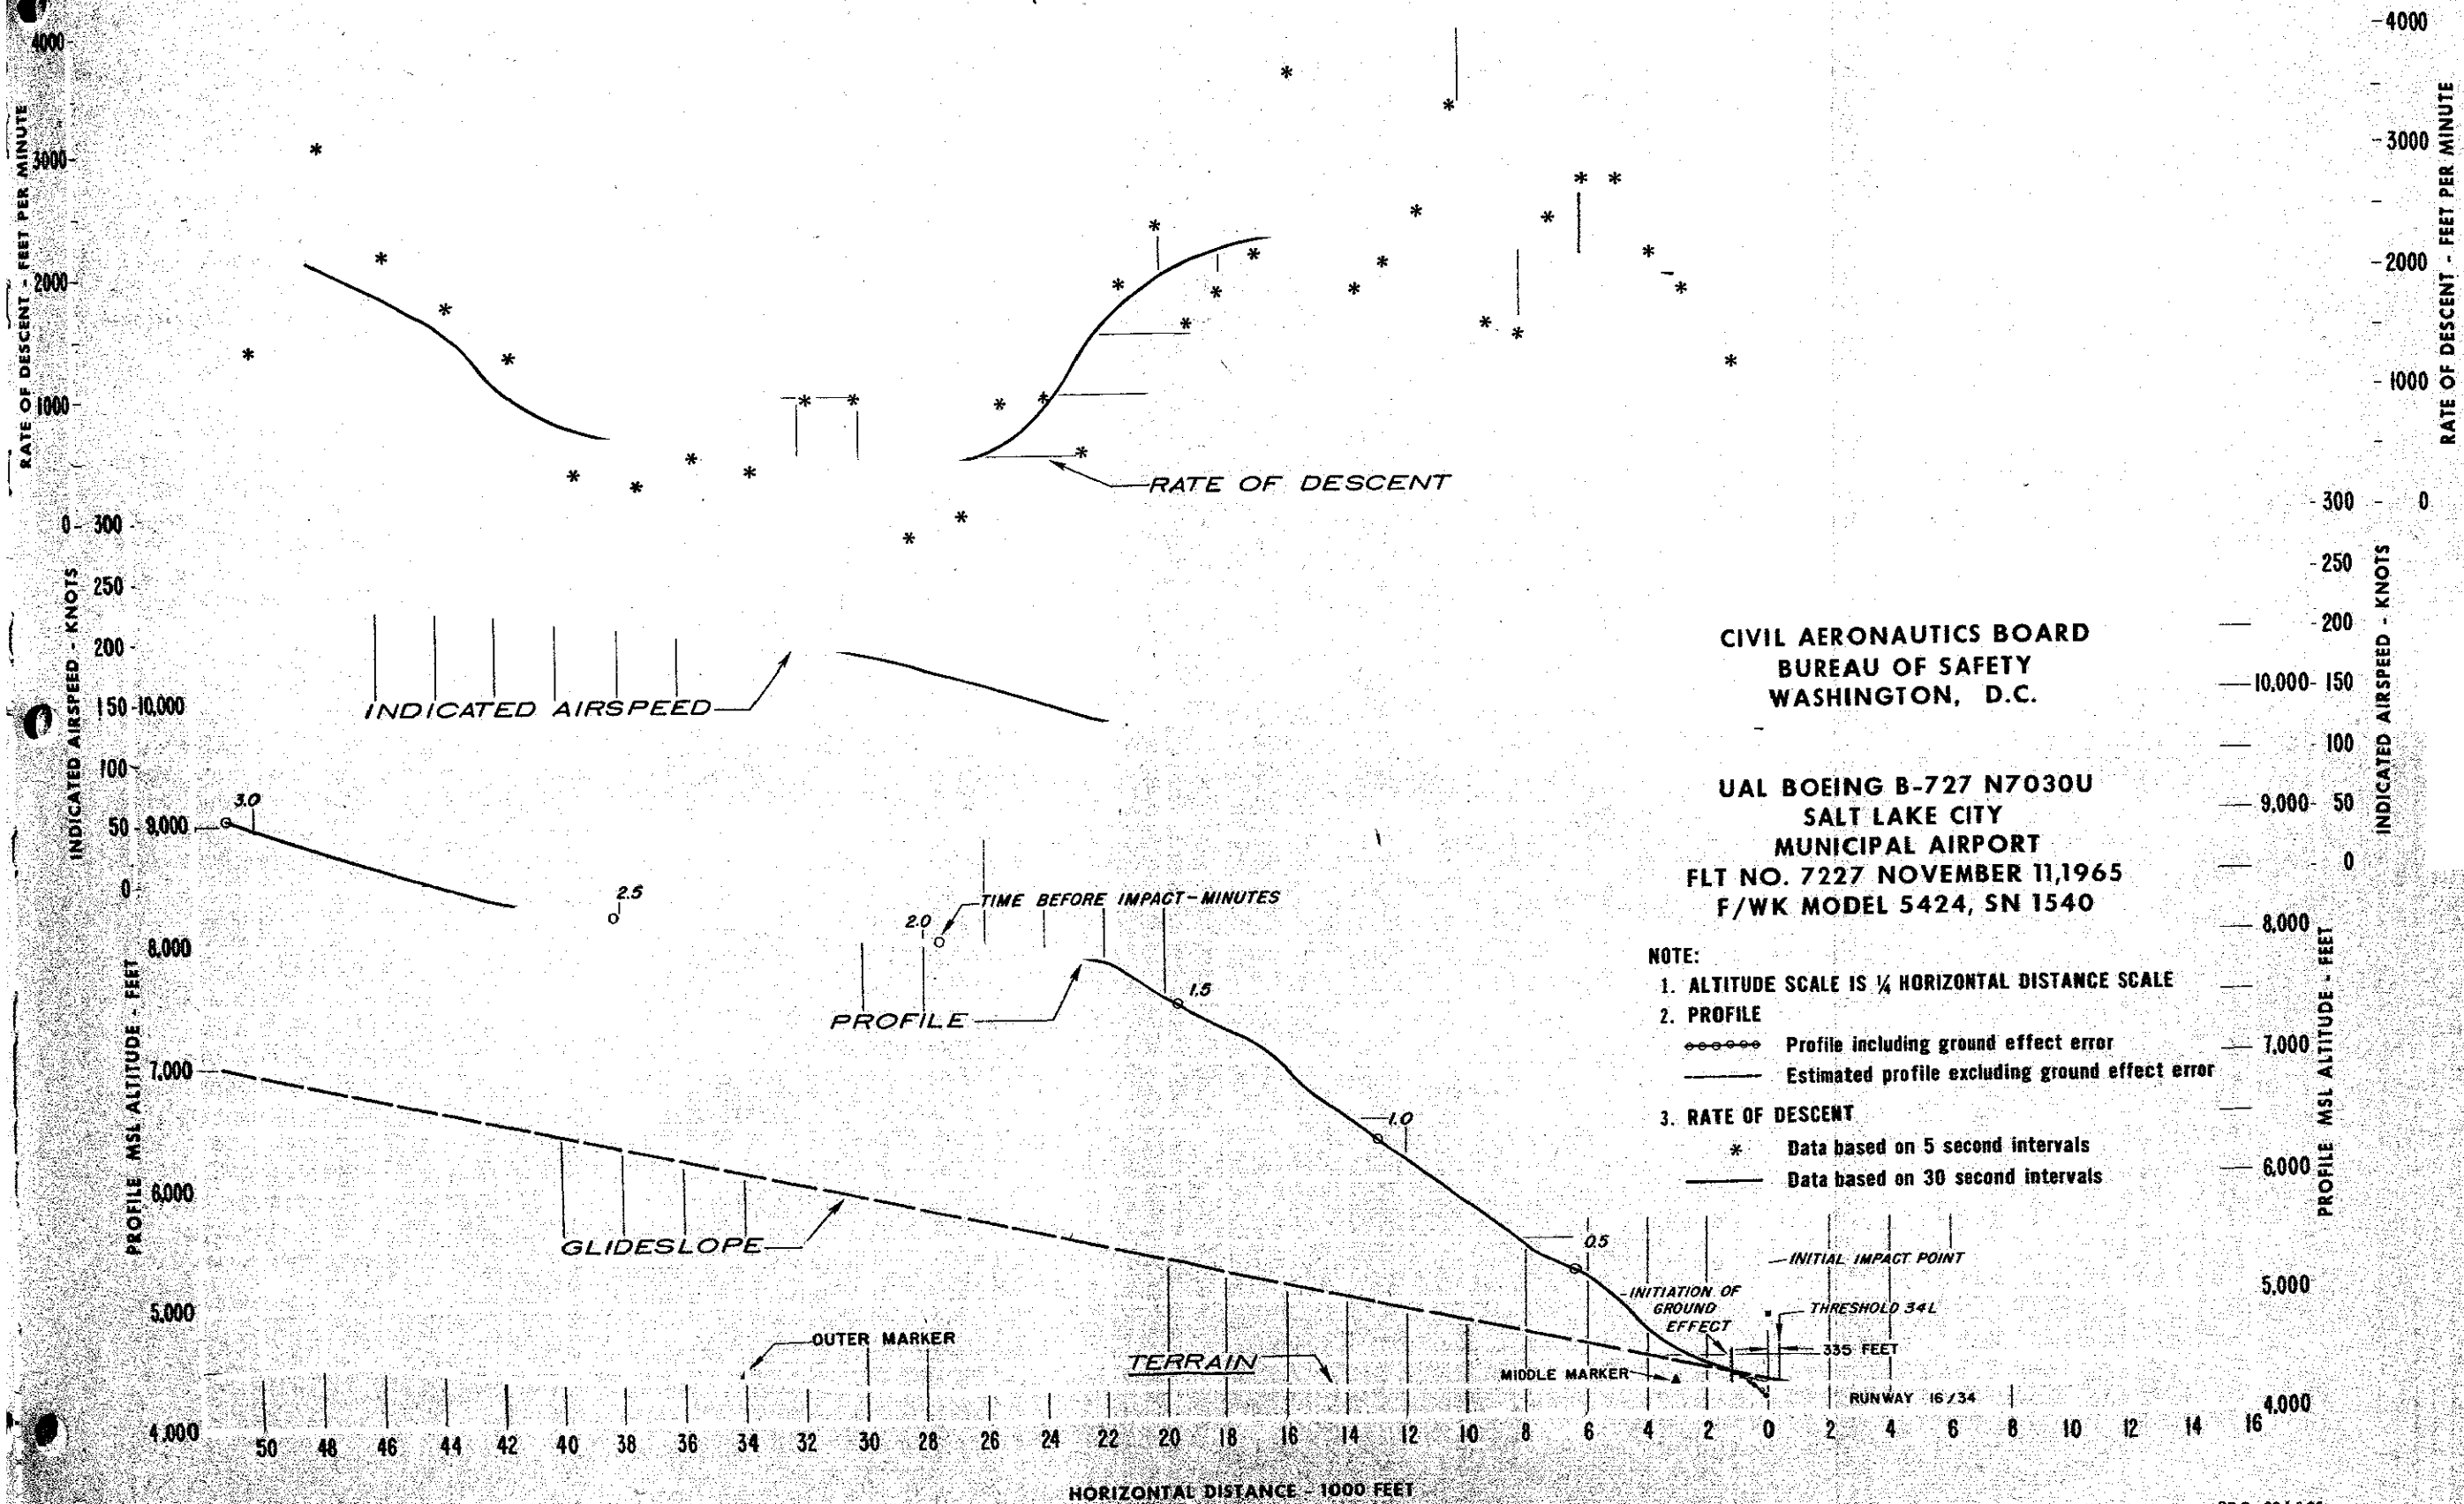
ATTACHMENT A

(BASED ON FLIGHT RECORDER DATA)

UAL BOEING B-727 N7030U
SALT LAKE CITY
MUNICIPAL AIRPORT
FLT NO. 7227 NOVEMBER 11, 1965
F/WK MODEL 5424, SN 1540
